# Top 10 Signs that you have Foundation Problem

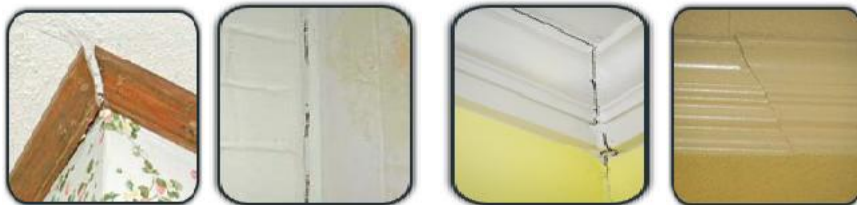
## 3. Displaced or Cracked Moldings

1. Crown molding separation
2. Cracked corner molding.

3. A crack running up the wall through the molding into the ceiling.
4. Close up of cracked crown molding.

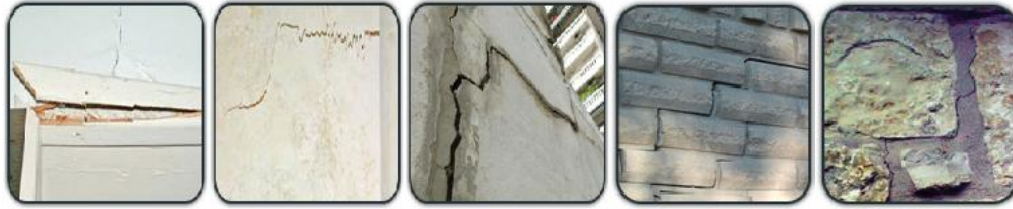
#### 4. Wall Rotation

1. The molding over this passageway has separated, and the painted paneling has split do to Rotation of the interior wall supports.
2. Wall rotation has caused this painted paneling to crack and split.
3. Wall rotation has caused a large crack to form on the side of this building.
4. Shrinking soil from the Central Texas drought has brought on wall rotation rendering this home unstable.
5. A new home experiencing wall rotation which has caused this crack in the mortar.

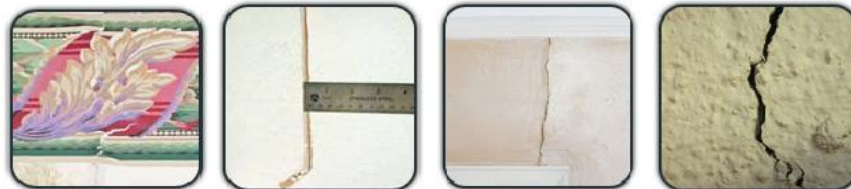
#### 5. Cracks in Walls or Bows in the Wall

1. Wallpaper border is torn due to cracking in painted paneling. Note wall and ceiling Separation at top of picture.
2. Vertical crack in sheet rock.
3. A prominent wall crack running between the door and the ceiling.
4. Large crack in a wall from foundation movement.

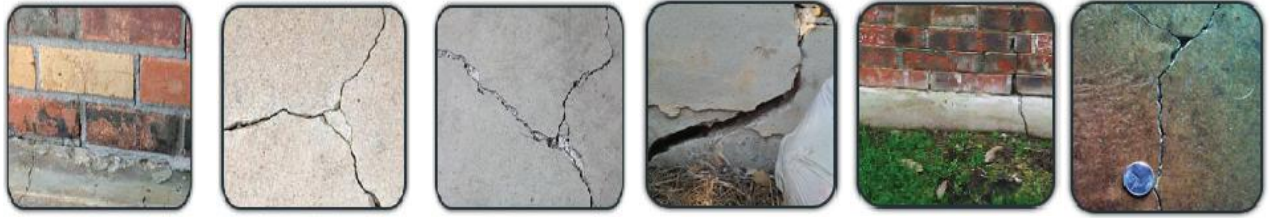
#### 6. Cracks in Floor, Floor Tiles and/or Foundation

1. Stair step crack that goes through foundation.
2. Crack in concrete floor.
3. A cracked slab from foundation shifting.
4. A severe crack running through the foundation of the home
5. Soil contraction has caused a crack which runs through the foundation.
6. This y-shaped floor crack is from a four (4) year old home.

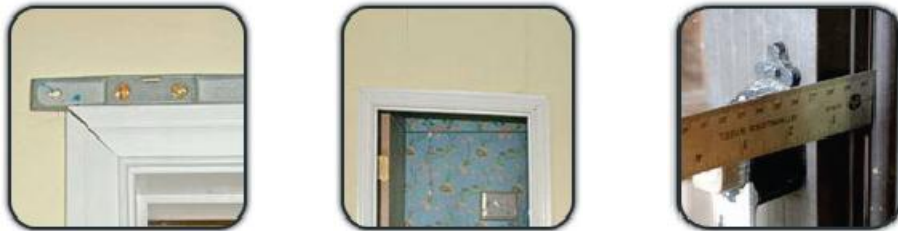
### 7. Doors and Windows Won't Open or Close Properly

1. Close up door frame separation. Level (tool) shows the degree to which the door is out of level.
2. Horizontal drop across door because foundation is sinking toward the middle. Note Characteristic separation of door frame on left and vertical cracks in sheet rock.
3. Close up of storm door that won't close completely because frame is no longer square.

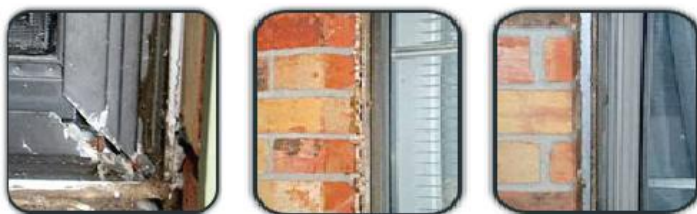
### 8. Separation of Doors, Windows and Garage Doors

1. Separation of window frame.
2. Brick has separated from window frame.
3. Brick has completely separated from framing. Gap is approximately 2" wide and deep. Light gray  
Vertical stripe (center) is the exposed window frame support and interior wall construction.

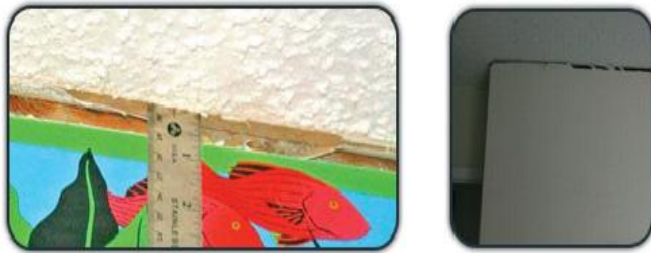
### 9. Spaces between Wall and Ceiling or Floor

1. Gap between wall and ceiling.
2. Foundation movement has caused separation between this wall and ceiling.

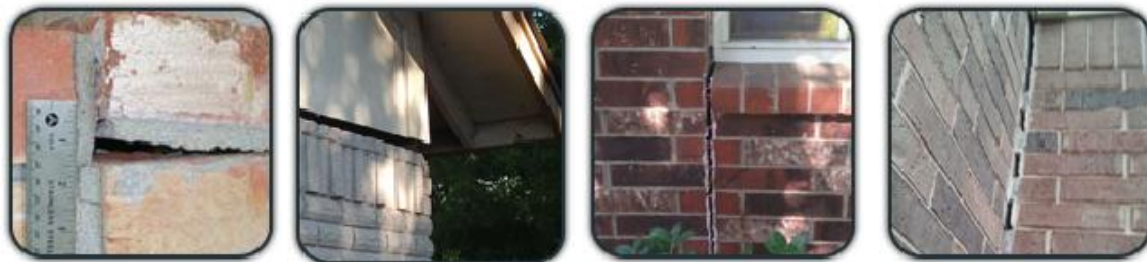
### 10. Walls Separating From House

1. The brick facade on the wall is pulling away from the house. The result of this separation can be sudden Catastrophic collapse of the entire wall.
2. The wall on this home has sunk from the shrinking soil caused by the Texas drought causing the Separation of the roof from the house.
3. Unstable, shrinking soil has caused foundation damage as evidence by the splitting running through the wall.
4. Foundation movement caused by the severe drought in Texas has caused this home's wall to Separate from one another. Notice the gap at the corner where the house is splitting apart.
